SOUND CONTROL IN BELL TOWERS - GUIDANCE NOTES

Towers & Belfries Committee - SOUND CONTROL IN BELLTOWERS

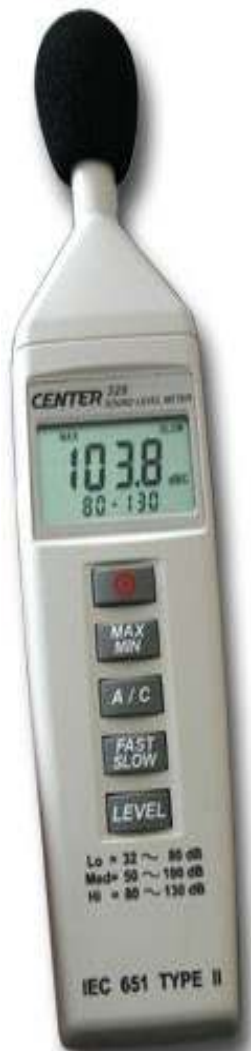
Measuring Sound Pressure Levels

- The human ear is most sensitive to sounds in the 500 Hz - 8 kHz range.
- Sound level meters incorporate electronic filtering to correspond with the varying sensitivity of the ear. This filtering is called A-weighting and measured sound pressure levels are signified as dB(A).
- There are two settings: the FAST setting attempts to catch peaks of sound whereas the SLOW setting averages sound levels over a longer time period.
- Ringers' perceptions of bell sound levels correlate well with use of dB(A) and a SLOW setting.
- Sound level meters are available at low cost (< £100).

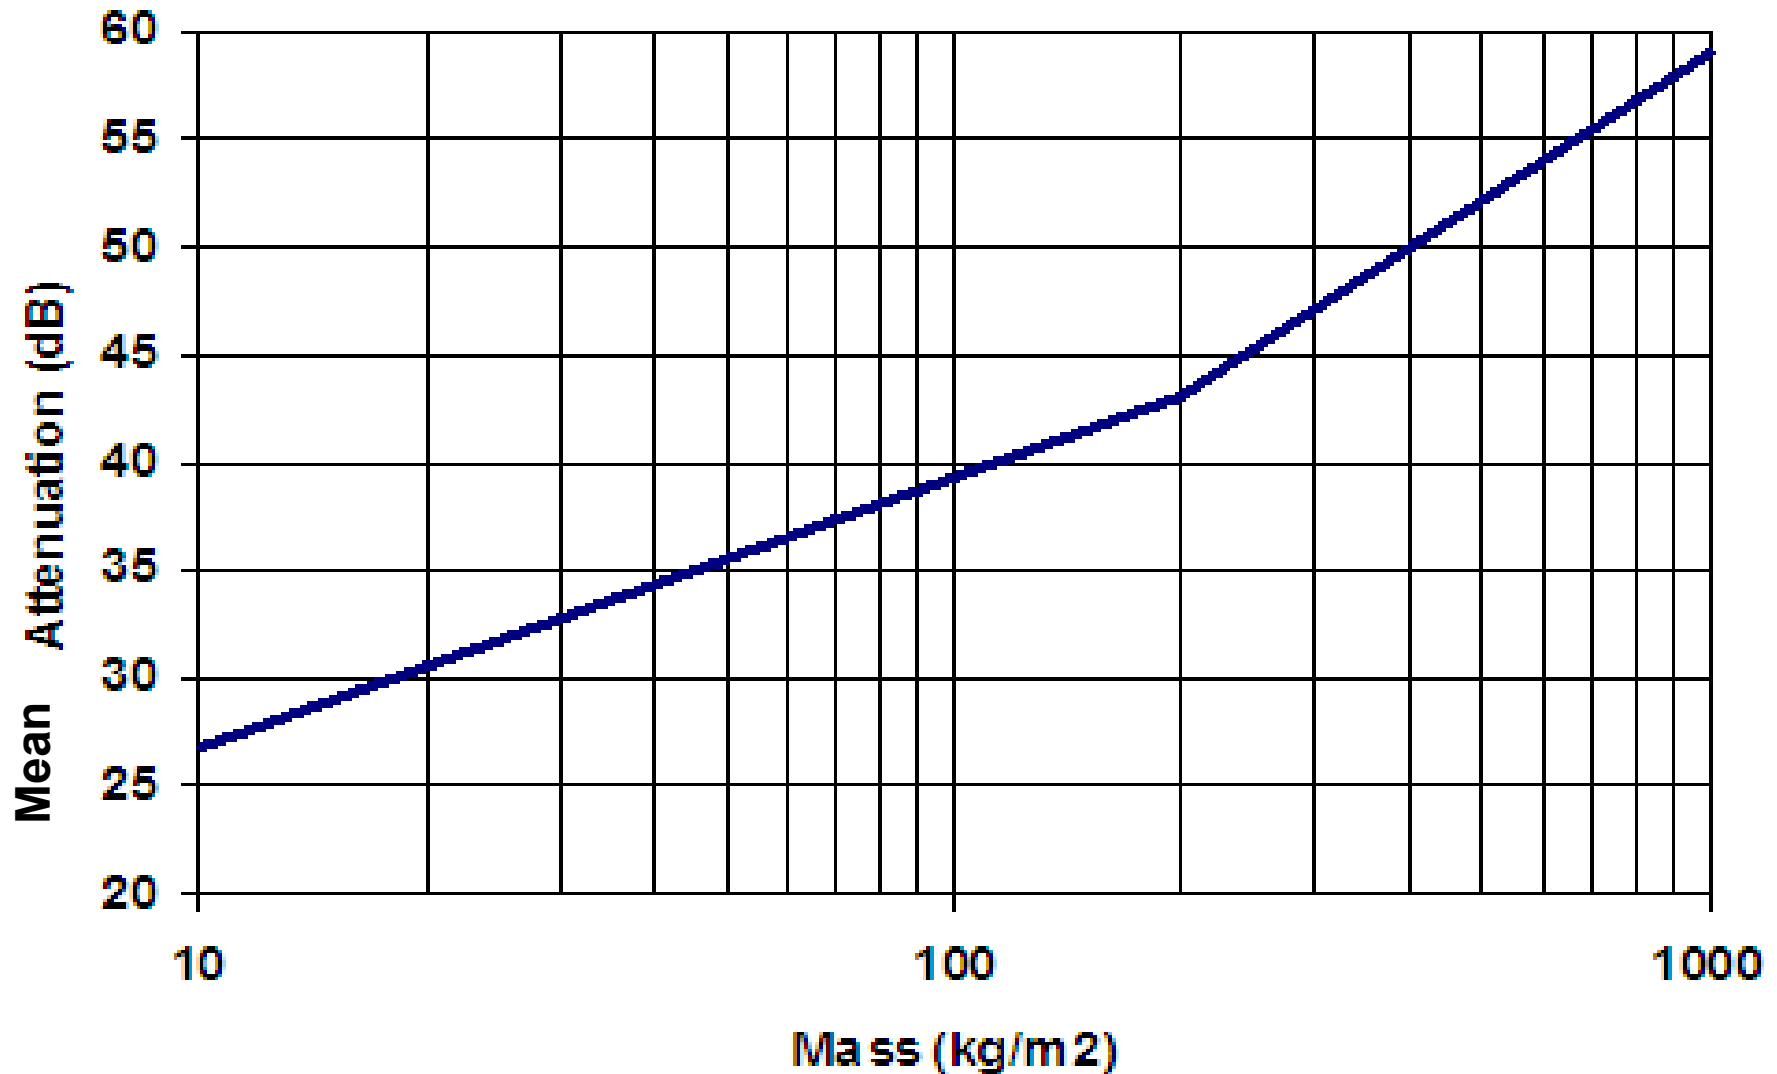
Estimated Sound Attenuation for Simple Barriers

- The mass of a wooden floor 25 mm thick is approximately 12 kg/m² (ignore mass of joists).
 - Using the graph, the estimated sound attenuation for the floor is 28 dB.
- The mass of a wooden floor 50 mm thick is approximately 24 kg/m² (ignore mass of joists).
 - Using the graph, the estimated sound attenuation for the floor is 32 dB.

- The mass of a concrete floor 200 mm thick is 460 kg/m².
 - Using the graph, the estimated sound attenuation for the floor is 52 dB.

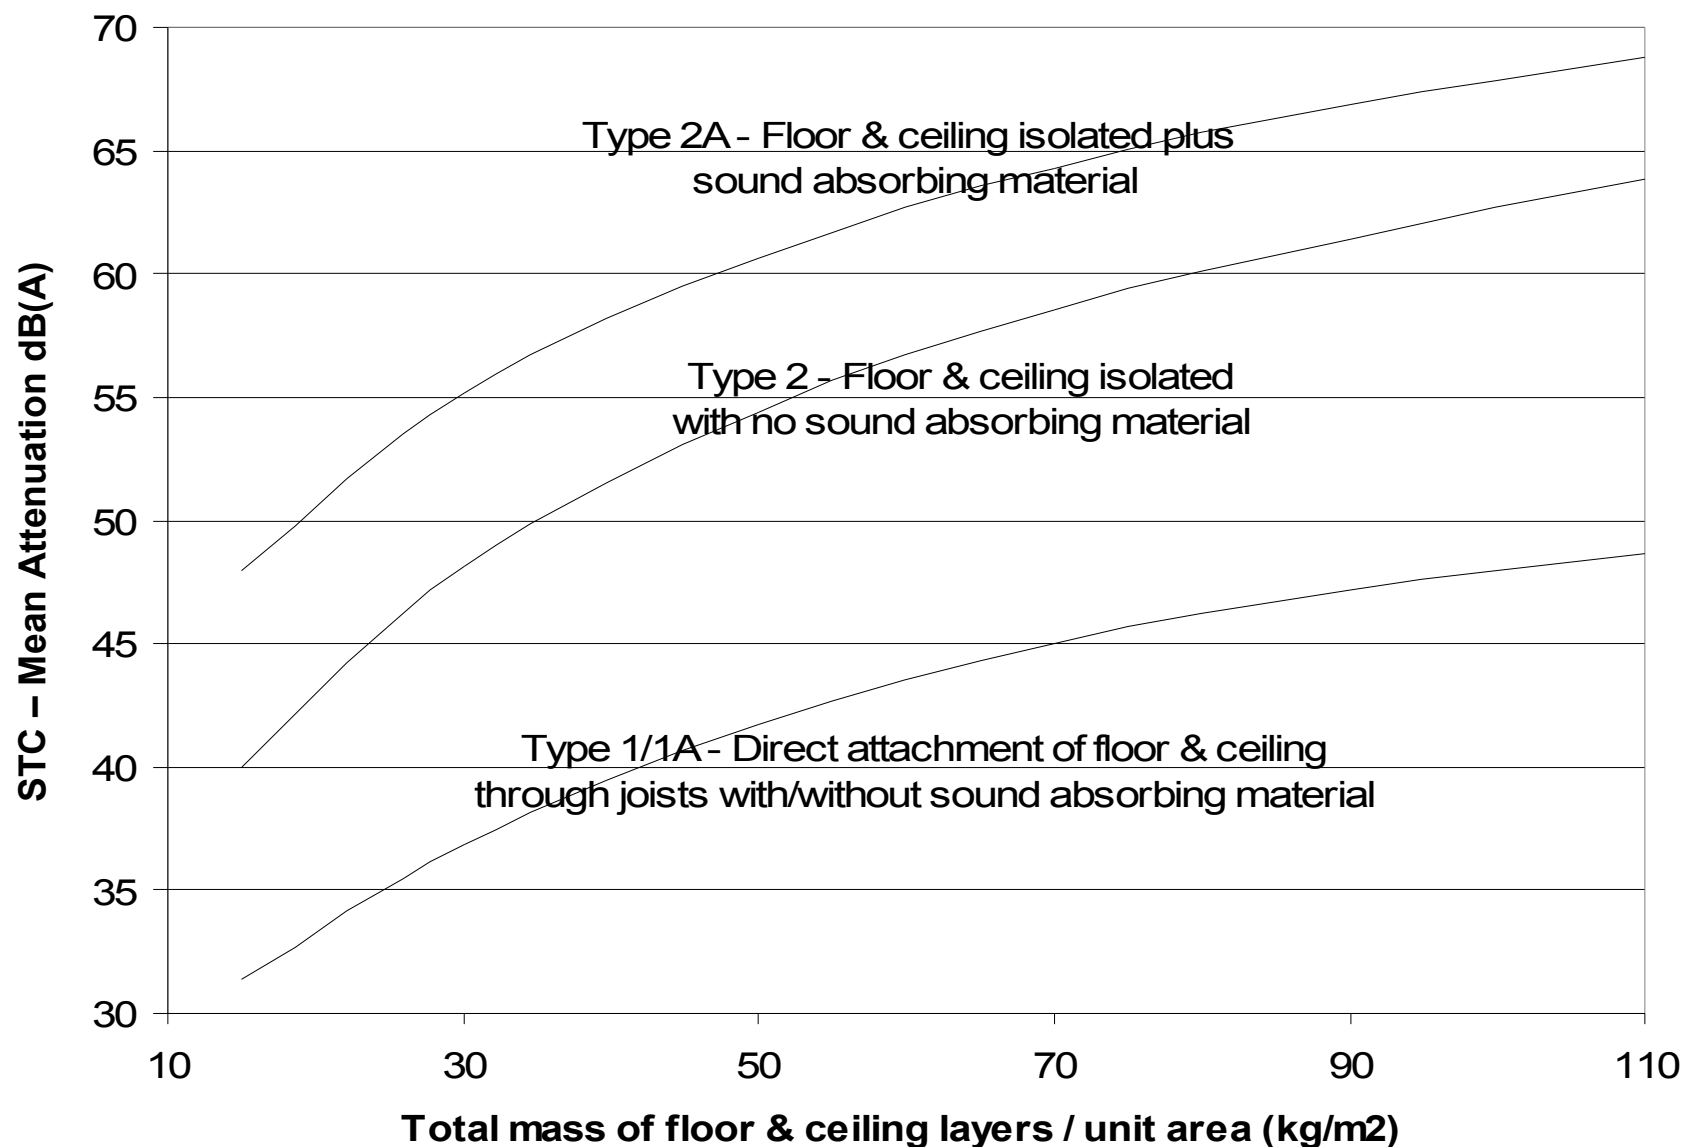
Estimated Attenuation - Composite Barriers

- Assume the floor and ceiling comprise 25 mm tongue and groove timber boards. The mass of the floor plus ceiling is 24 kg/m² (ignore mass of joists).
- From the graph, the estimated sound attenuation for barrier types 1, 2, and 2A are:

- For type 1 barriers (floor and ceiling not isolated) most of the sound is transmitted through the joists and:
 - attenuation is a little better than a simple barrier comprising material of the same mass / unit area
 - sound absorbent material does not particularly increase estimated attenuation but significantly reduces rope hole noise – see later.
- For type 2 barriers, acoustic / mechanical isolation of the floor and ceiling makes a big improvement to attenuation since sound can pass only via the air in the cavity. Sound undergoes reflections inside the cavity providing conditions in which sound absorbing materials work at their best.
- Composite barriers find greatest use in short draught towers where there is only one barrier between ringers and bells.

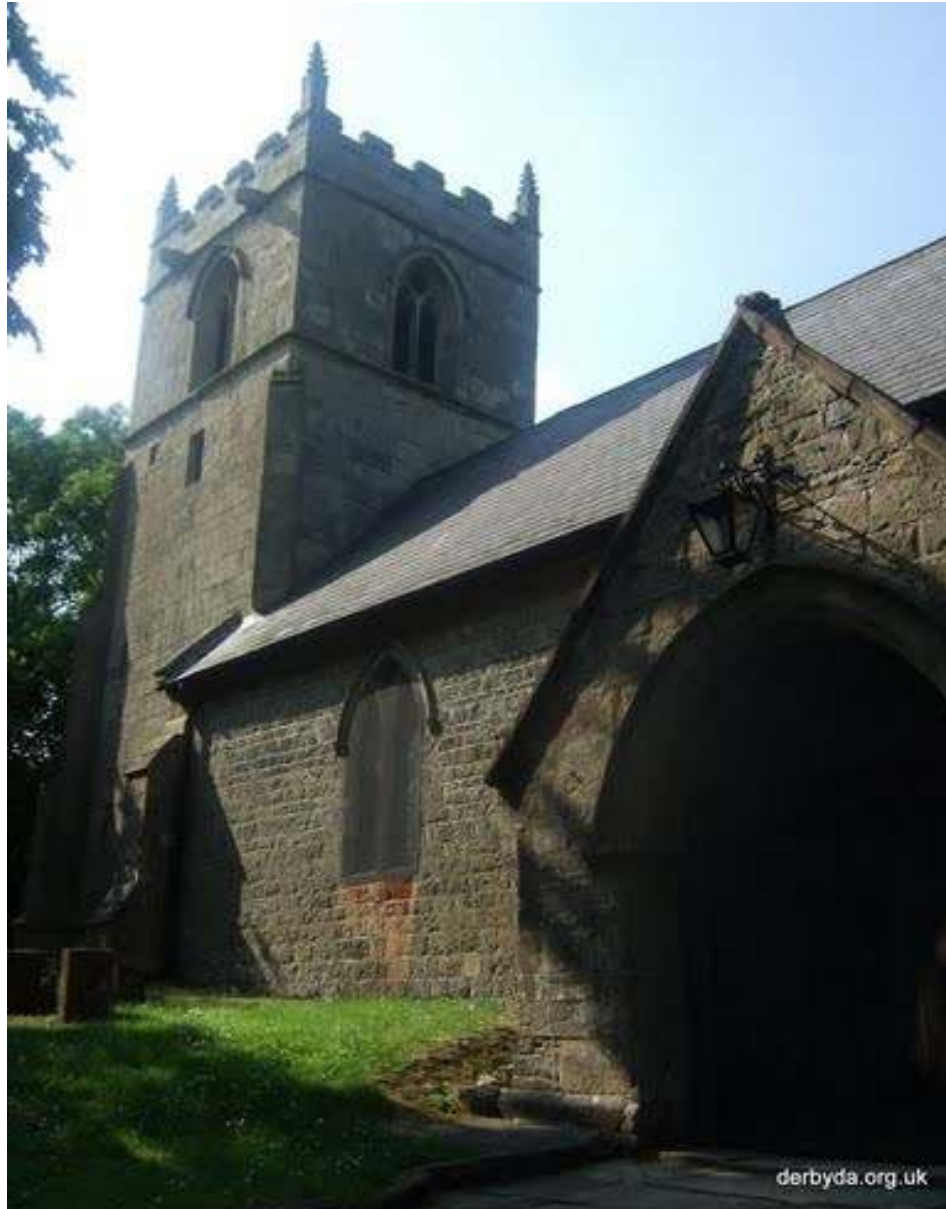
Measurement Procedures

- In towers with up to 6 bells, the peak sound level of the tenor bell rung by itself is close to the average sound level with all bells ringing. This fact is useful in situations where there are few ringers available during lengthy sound reduction trials, as in the case studies.
- A minimum of two people is necessary for sound level measurements – one to ring each bell in turn and one to read and record the levels keeping a full log of all acoustic changes and their consequences.
- Consistent, repeatable ringing is essential. The ringer must be competent at bell handling and all ringing carried out by one person since different ringing styles produce slightly different sound levels.
- Sound level readings should be taken for both hand and backstroke.
- Ear protection is essential in the bell chamber.
- Hold the sound level meter away from the body.

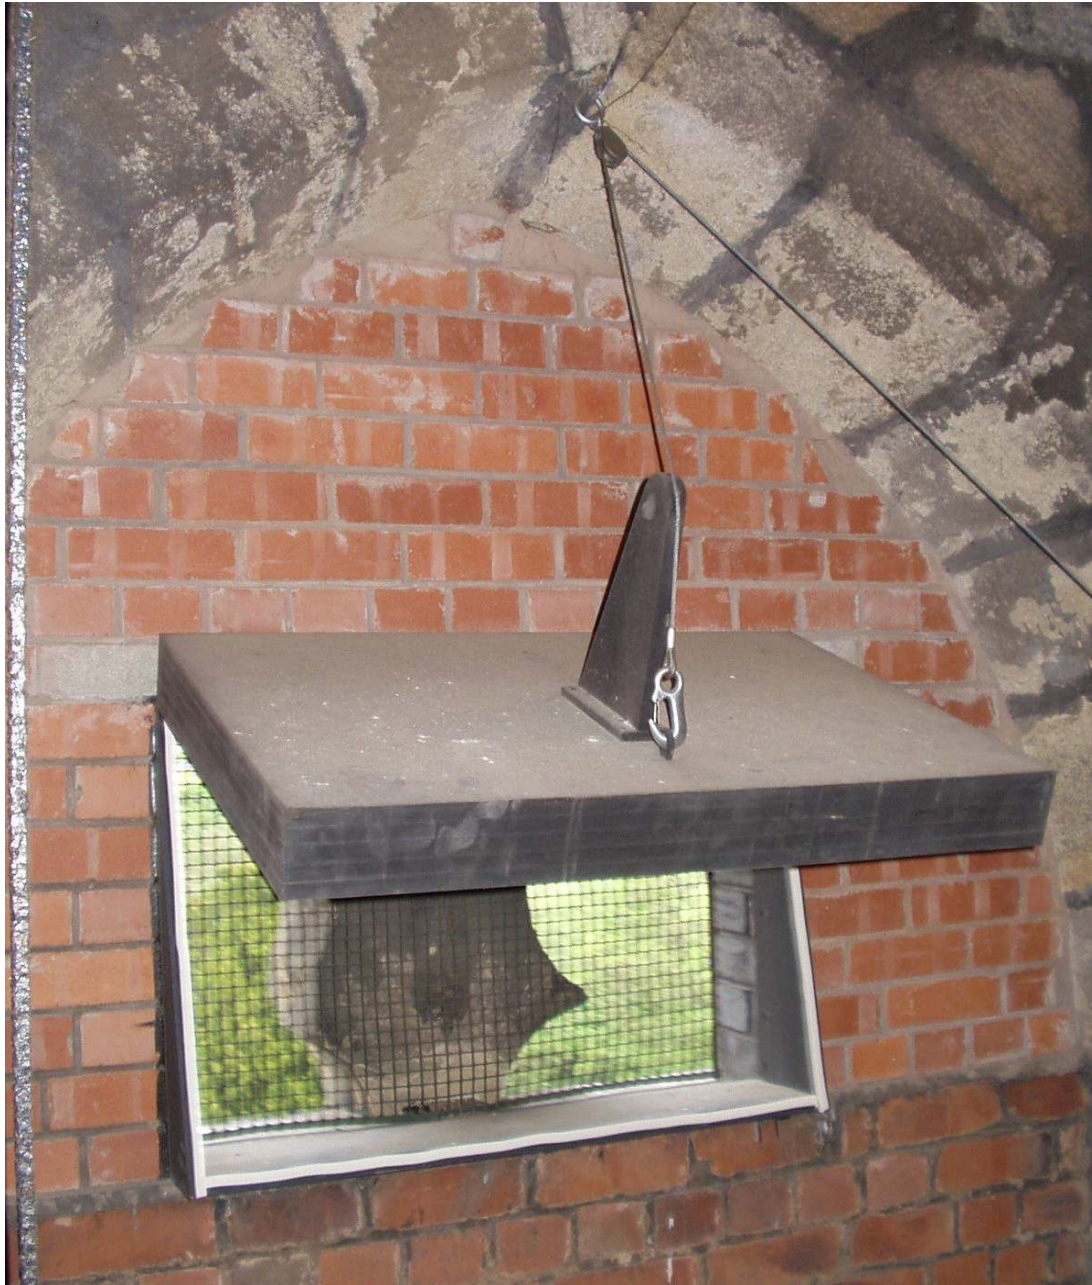
**Variable
Sound
Control
- Duffield**

- **Problem** – external sound levels for residents on Duffield Bank to the east, and in church hall to the south of the tower intrusive when peals rung.
- **Number of bells:** 10
- **Tenor weight:** 17-2-11
- **Tower configuration** - stone spire surmounting substantially built stone tower with one sound window to each of the four aspects. No spire openings other than ventilation opening at base of west side.
- **Remedial work** – brick sound barriers, incorporating gravity-closing sound control doors, fitted to south and east sound windows only. Each door opening size 860 X 570 mm.
