Stewardship & Management Workgroup

of The Central Council of Church Bell Ringers

Church Tower Access

A Guide for Bell-Ringers

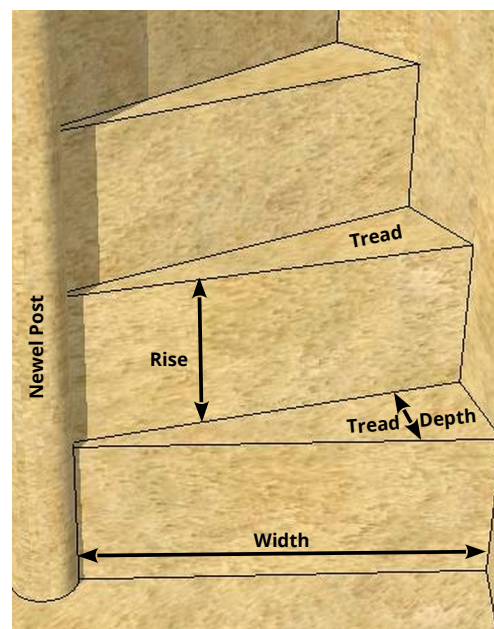
Figure 1

The terminology used is all covered by the diagram below. Definitions are given alongside.

- **Newel / Newel Post:** the central column of a spiral stairway.
- **Rise:** the height of a stair from the tread below.
- **Tread:** the horizontal surface of a stair upon which users step.
- **Tread Depth:** the horizontal distance from the front edge of a tread to the back edge. For spiral stairs an indicative value is measured 300mm (12") from the outer wall of the stairway.
- **Width:** the distance between the outside of the newel post and the outer wall of the stairway.

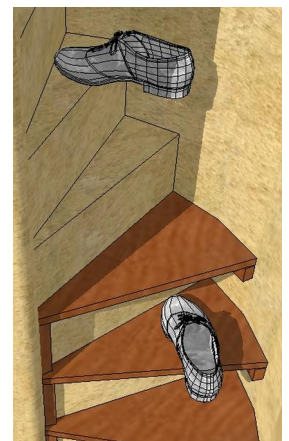
Figure 2

When a spiral stairway is excessively steep the depth of the treads can be so small that the user is climbing with only their toes on the tread and descending on their heels. In such a situation it is possible to have wooden treads fitted which extend forward from the stone ones. These allow the user to put more of their foot upon each tread while the tread above overhangs. (See figure 2)

Such extended treads **MUST** be supported at the front edge by suitable brackets or blocks fixed to the outer wall and newel post.

Stairs modified in this way should be descended backwards or the advantage is negated.

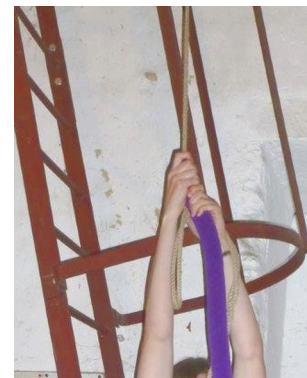
Figure 3

Some modern fixed ladders are fitted with hoops which are designed to reduce the risk of falling but before installing such a hooped ladder the implications should be considered. If the ladder is in the ringing room as access to the room above the hoops may be too close to the rope circle and cause a risk of entanglement or indeed injury to a ringers hands (see figure 3). The hoops can also make it difficult to carry tools or to move stays or clappers to and from the bell chamber.

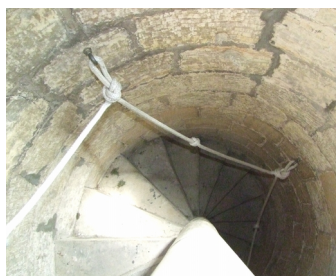
Figure 4

A hand-rope suffers from an even worse form of the same problem. If the rope is fixed even as often as six times per turn of the stairway it will reduce the usable width by more than 15% due to the rope 'cutting the corner' off the stairway.

An extreme example may be seen in figure 4.

As a result external hand ropes should not be installed unless fixed very frequently and in a wide staircase.

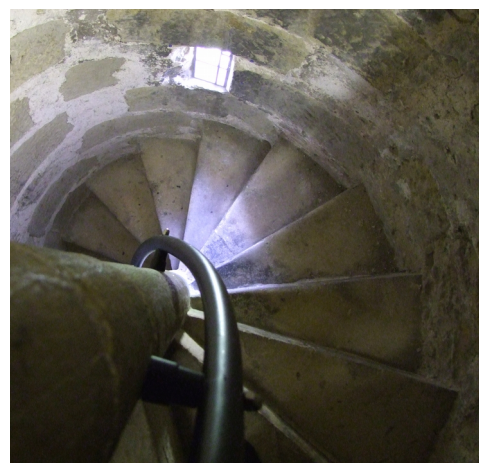
Figure 5

Internal hand-rails and hand-ropes are also found in many towers and have the advantage of allowing the user to traverse the largest part of the stair tread. An internal handrail may be fixed as little as 3 times per turn of the stairway without disadvantage (see figure 5).

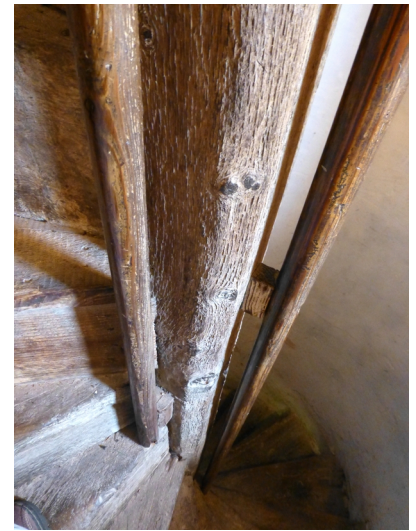
Figure 6 shows a series of vertical handrails on a stair-way which has much to recommend it. It is suitable for users of any height, it is sturdy and takes up minimal space. It is also very easy to install.

Tough plastic water pipe is often used as a cheap handrail that can be easily fitted. The supporting brackets must of course be close enough together to provide adequate support and stiffness to the handrail (see figure 6). MDPE water pipe may be purchased in coils of 25 or 50 meters length and in various diameters. For handrails 25 or preferably 32 mm diameter should be used.
