Lighting in and around church towers – a guide for bell-ringers

Central Council of Church Bell Ringers

Towers and Belfries Committee

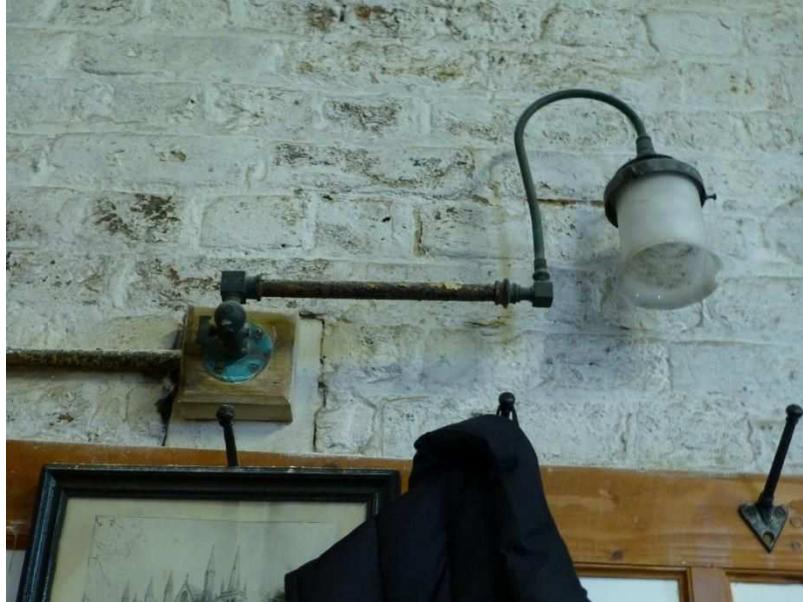
Is this the state of the art in your tower? Gas lighting is not state of the art!

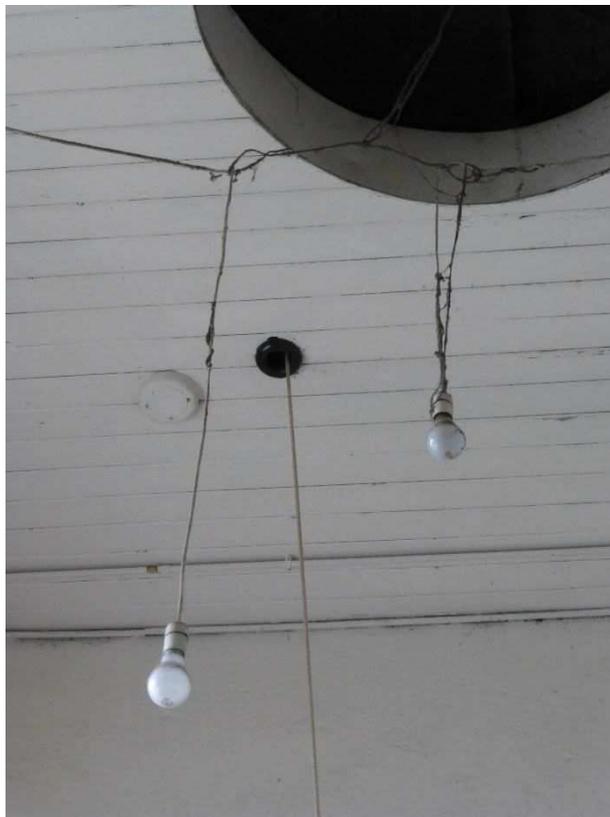
Not an acceptable arrangement!

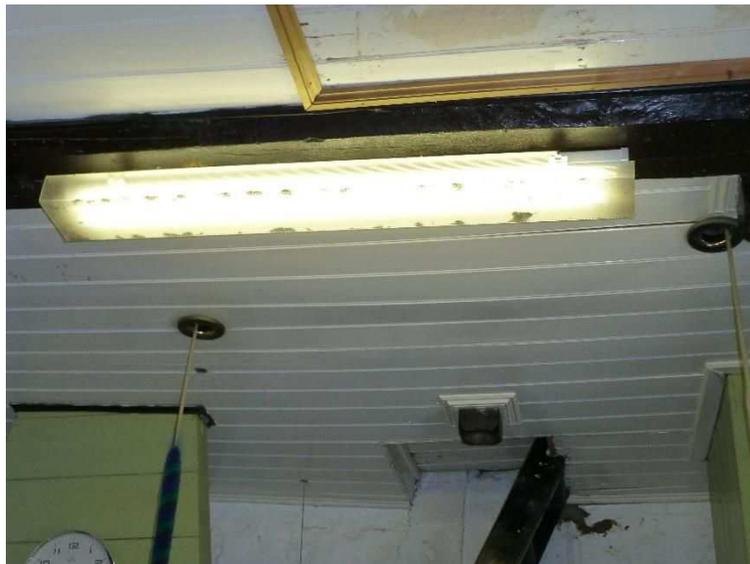
The picture above shows a typical strip light with diffuser, now with some debris building up.

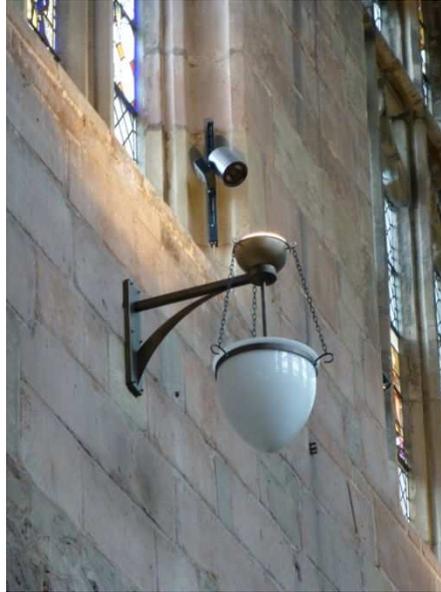
This picture shows a recent installation in the body of a church - a dual fitting with uplighter and down-lighter and, adjacent to this, a spot light. This arrangement enables different lighting effects for different functions in the church. However, this would not be suitable in a ringing room. The challenge here is that scaffolding is required for every bulb change, and debris is already building up in some of the globes. No doubt, dust will also be settling on the uplighters and hence reducing efficiency.

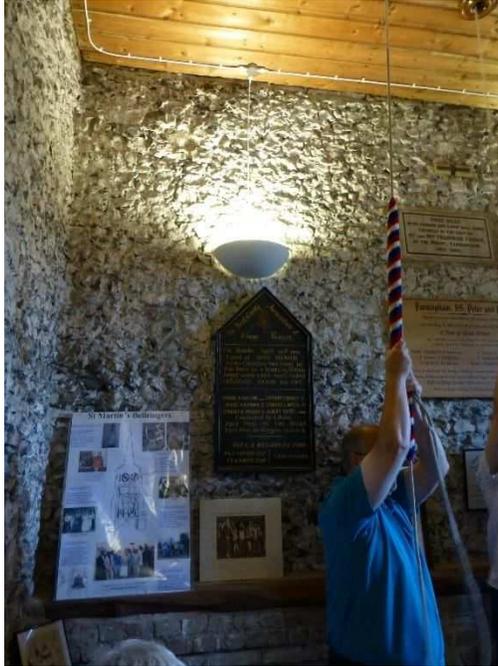
In the picture above, the uplighter is giving a good light out of the way of ropes and ringers. Inevitable, it may still collect debris.

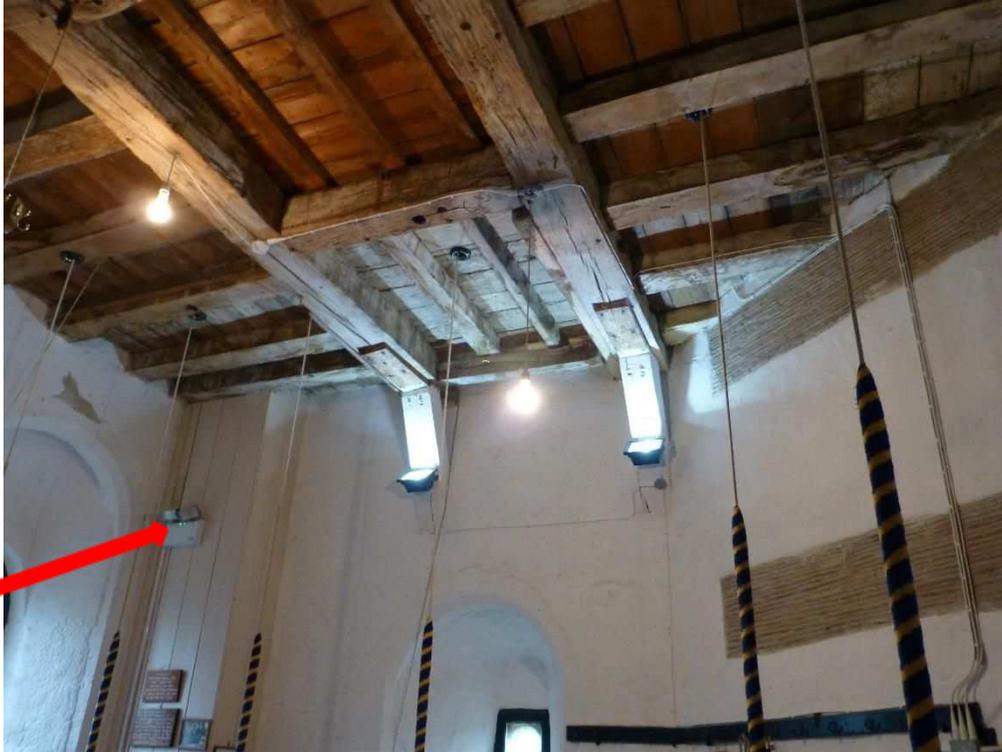
In this tower (above), there are bulbs and uplighters, with emergency lighting (arrowed).
