Lighting in and around church towersa guide for bell-ringers

Alison Hodge
Central Council of Church Bell Ringers
Towers and Belfries Committee
December 2016

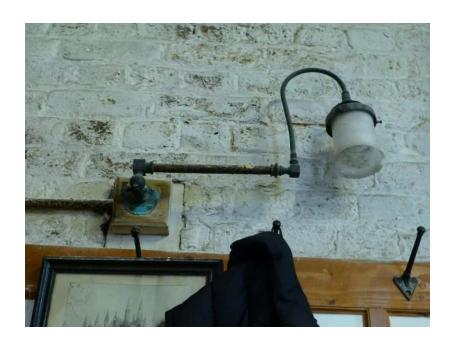
Is this the state of the art in your tower? Gas lighting is not state of the art!

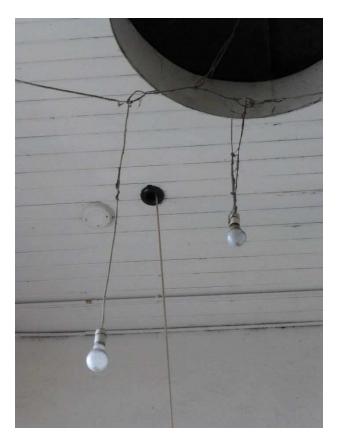
Not an acceptable arrangement!

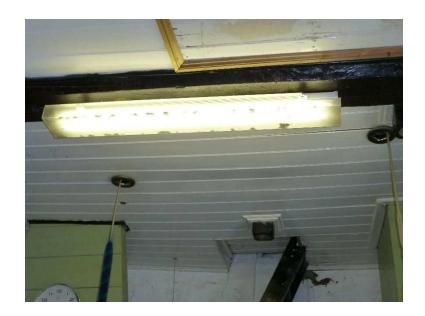
The picture above shows a typical strip light with diffuser, now with some debris building up.

<u>Shading</u> – The light must be diffuse; depending on the source, diffusers may be required. Many modern sources are much more intense and directional than traditional bulbs so care is required when installing new fittings at the same location as a previous lamp. The style of shade also requires careful selection. If dust, insects, spiders or other debris can easily collect in a shade or diffuser, this will soon reduce the light efficiency and potentially become a fire hazard. Ringers should not be expected to clean out lamp shades, at frequent intervals.

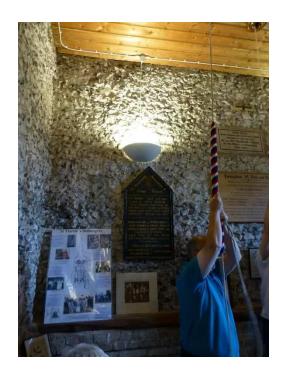
In the picture above, the uplighter is giving a good light out of the way of ropes and ringers. Inevitable, it may still collect debris.

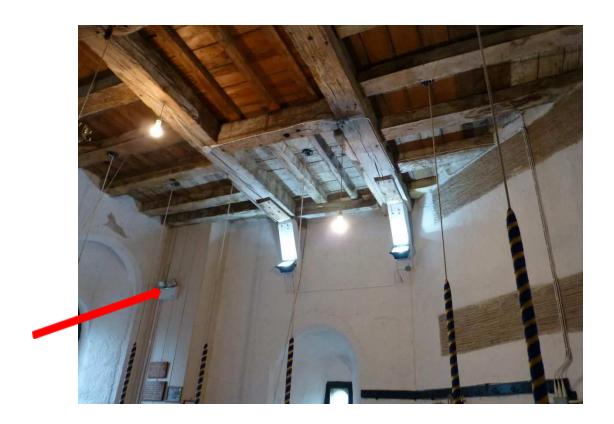
In this tower (above), there are bulbs and uplighters, with emergency lighting (arrowed).

Emergency systems – This should be integrated with the church system in case of power cuts. Ideally, the lighting is integrated with the emergency exit signage. The light source is usually a low power consumption lamp run from rechargeable batteries. Integrated emergency lighting is normally installed with fire / heat proof cable. If not integrated with the church system, then a separate system may be purchased and installed relatively economically and safely. While most people using the church may expect to leave in the event of an extended power failure, ringers may (if safe otherwise to do so) wish to continue ringing for up to 45 minutes or even the greater part of 3 hours! Whatever approach is adopted, the system should be tested periodically.
