# Checklist for recommencing ringing

Guidance for steeplekeepers and tower captains

## Case Study: re-start of ringing in the Isle of Man

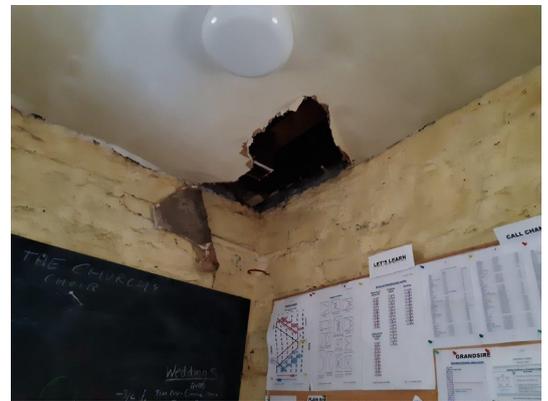
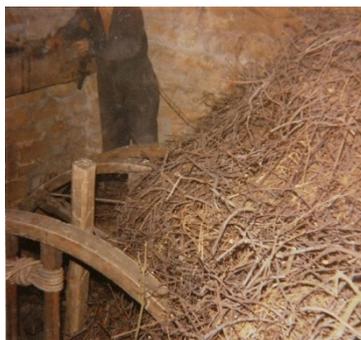
*Birds nest found after a prolonged period of no ringing*

These experiences emphasise the importance of working with the church authorities. Regular inspections are ideal, however a full inspection of the installation prior to ringing should be carried out by an experienced person.
