Checklist for recommencing ringing

Guidance for steeplekeepers and tower captains

Case Study: re-start of ringing in the Isle of Man

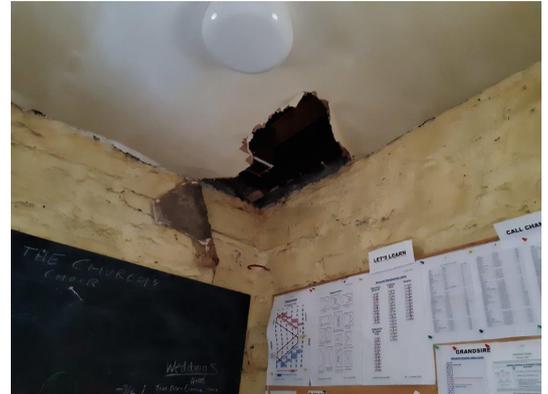
As churchwarden at Douglas, ringer Ernie de Legh-Runciman checked the tower once a week. On the 7th April, the damage to the plaster ceiling was found. Approximately 4 m² of plasterboard in the corner of the ringing chamber had fallen down. If the tower had not been inspected, this damage would not have been found until ringing resumed, which would have delayed the re-start as a contractor was needed to complete the works.

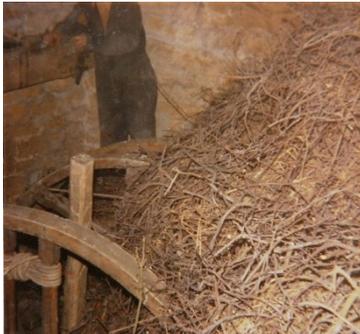
Birds nest found after a prolonged period of no ringing

Check for nesting birds, squirrels, etc
